| | DOC No:<br>AEU00508 | TITLE:<br>CLEAN ROOM - UV FILTER<br>REPLACEMENT | | | <b>Advanex Europe Ltd</b><br>Head Office: Southwell Site<br>Mill Park Way, Southwell<br>Nottinghamshire, UK, NG25 0ET<br>☎: 00 44 (0) 1636 815555<br>☎: 00 44 (0) 1636 817725<br>Bilborough Site ☎: 00 44 (0) 115 9293931<br>☎: 00 44 (0) 115 9295773<br>Video Conference IP:80.176.189.113<br>www.advanexeurope.co.uk<br>general@advanexeurope.co.uk |

## 1.0 PURPOSE

- 1.1. The purpose of the document is to define the SOP (Standard Operating Procedures) to be followed by ADVANEX EUROPE Ltd, in order to ensure that the Ultra Violet Filter used on the Purite system for the clean room is maintained in a controlled and consistent manner to assure compliance with ISO 14698 for the required class of operation.

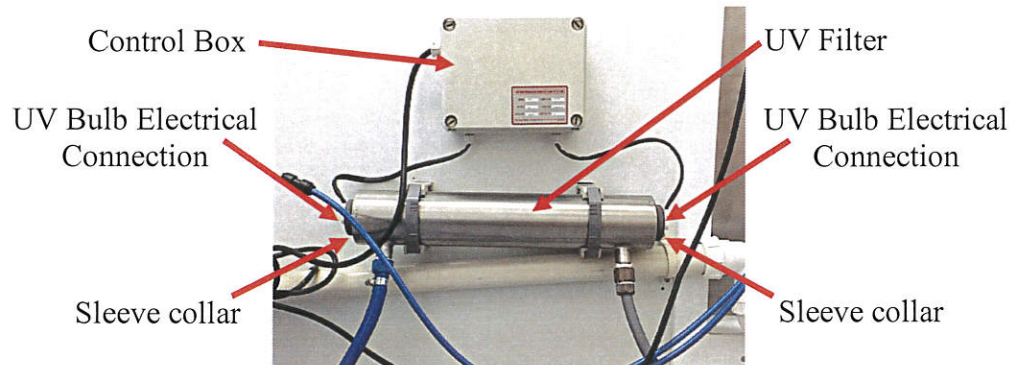
Figure 1: The UV Filter System for Clean Room 1 (CR1).

- 6.2.1. **Check the Operation of UV System.** Check the operation of the UV System by ensuring that the alarm is not activated.

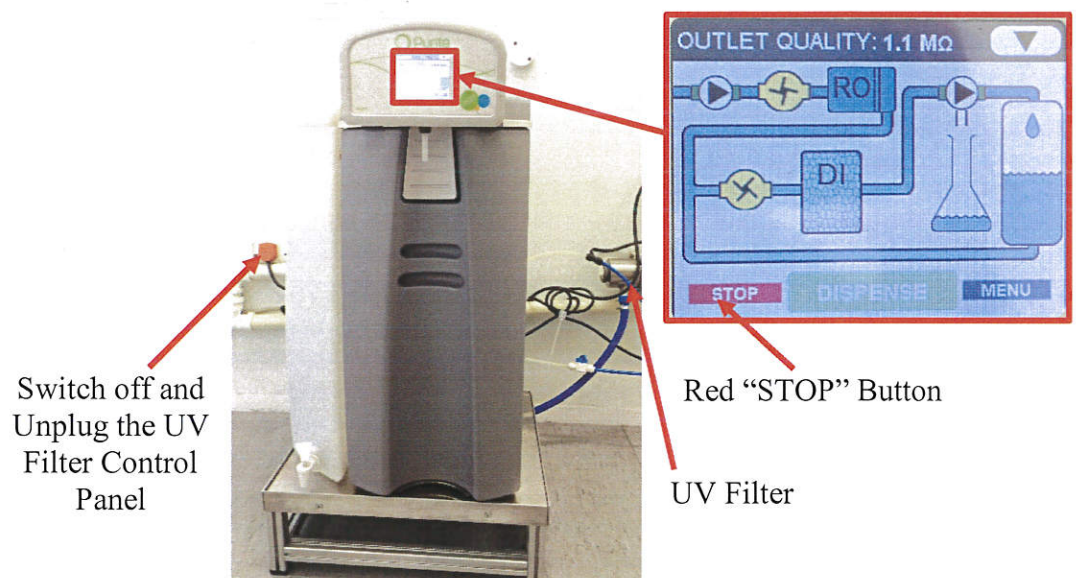
Figure 2: Purite System for CR1, shown with a zoomed in view of the control panel.

- 6.2.2. **Switch Off Filter Unit.** Switch off the filtration unit at the control panel by pressing the red "STOP" button, as identified in Figure 2:
- 6.2.3. **Isolate the Electrical Supply.** Switch off and un-plug the electrical supply for the UV filtration system, as shown in Figure 2:
- 6.2.4. **Let System Cool.** Allow the system at least ten minutes to cool down from operational temperatures.

6.2.11.2. **Power Up System.** Reconnect the electrical supply removed in step 6.2.3 then switch on the control panel as described in step 6.2.2.

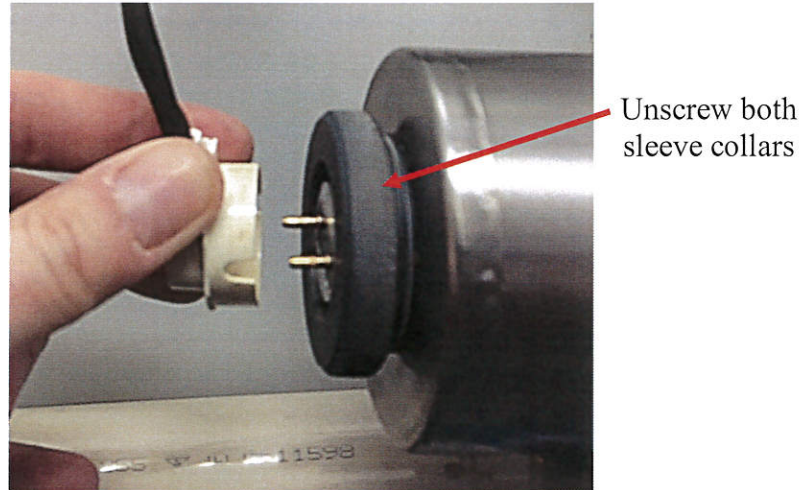
Figure 3: Removing the electrical connectors.

6.2.5. **Remove Electrical Connectors.** Remove the electrical connectors from each end of the UV filter unit by pulling the connectors off the bulb, for the second end the bulb will have to be held by a gloved hand to remove the connector.

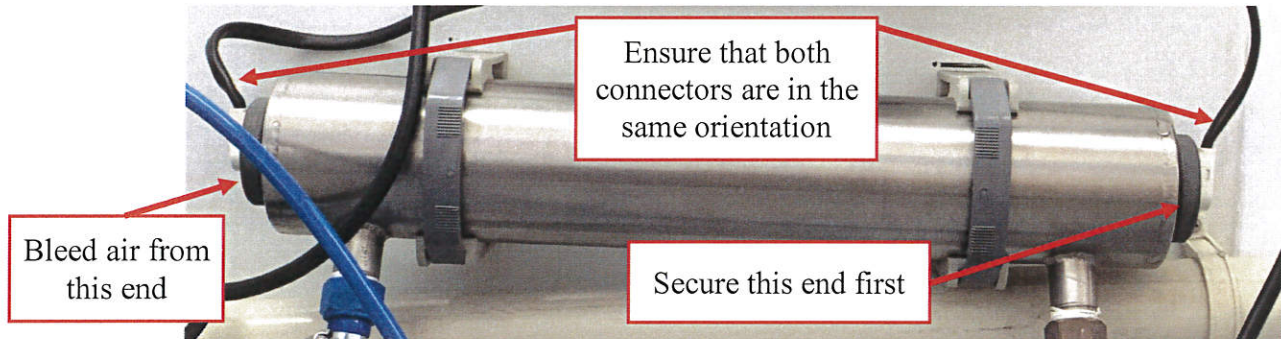
Figure 4: Reconnect the electrical connections.

6.2.9. **Reconnect the Electrical Connections.** Ensuring that both the electrical connections are replaced in the same orientation as each other, as indicated by both the connecting wires shown in Figure 4:

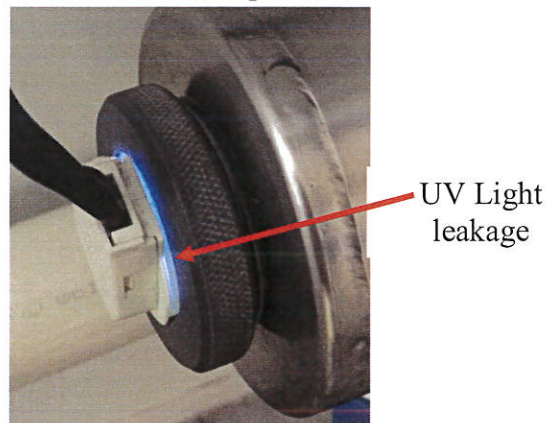
Figure 5: Ensuring the correct operation of the UV Bulb by looking for light leakage.

6.2.11.3. **Ensure Operation of the UV Bulb.** Once the UV System has been powered up, switch the lights off in the surrounding area and look around the ends of the UV Filter for UV light leakage, as shown in Figure 5:

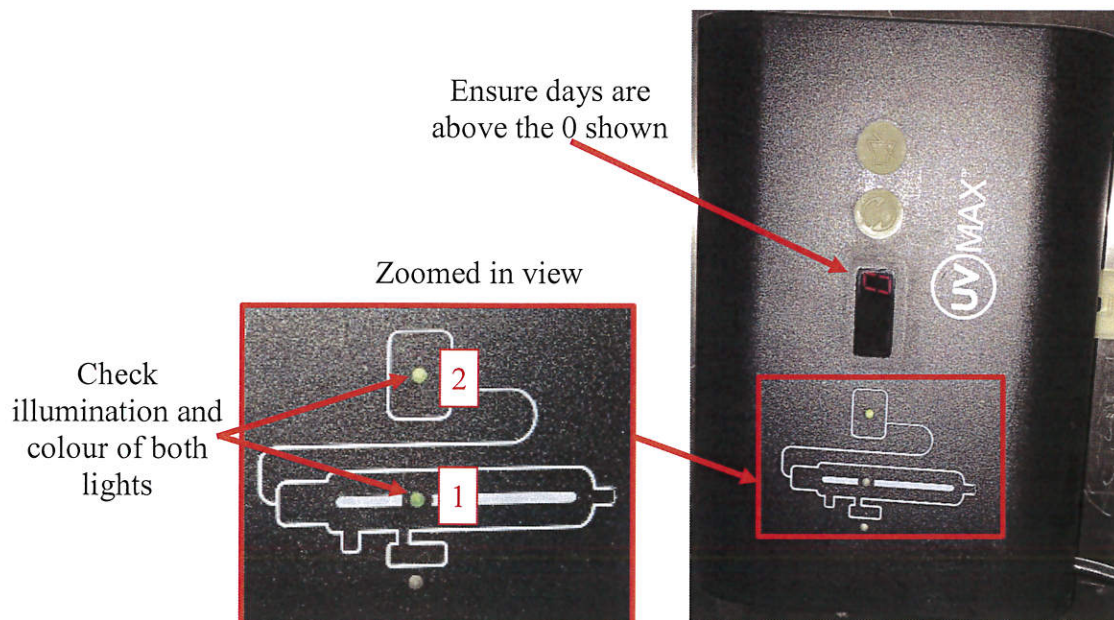
| Indicator Number | Green light | Yellow light | Flashing Red light | Solid Red light |
| 1 | Lamp operating normally | Warning; lamp will require replacement shortly | Lamp disconnected; unplug system, reconnect lamp and plug-in system<br>Lamp failure; replace lamp | Lamp inactive due to power supply failure |
| 2 | Power supply operating normally | Air temperature around system is too warm | Power supply failure; replace power supply | Power supply inactive due to lamp failure |

Figure 6: Check the operation of the UV system, the location of which is shown in Figure 8:  
Zoomed in view showing the UV bulb working.

6.3.1. **Check the Operation of UV System.** Check the illumination of both status lights and ensure that they are both green in colour, as detailed in the table. The bulb life days counter is also to be checked to ensure that the serviceable days remaining is above the Zero (0) shown in the example in Figure 6:

Figure 16: Reset the UV Lamp Life Counter, if new bulb was fitted. The controller is shown after the lamp life counter has been reset, Figure 6: is an example of the counter before it is reset.

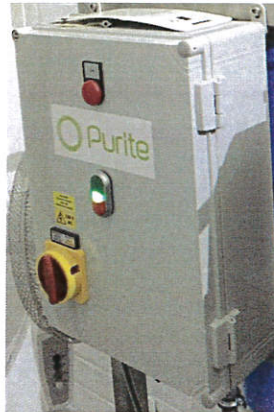
Figure 7: Filtration unit control panel.

6.3.2.1. **Switch Off Filter Unit.** Switch off the filtration unit at the control panel by pressing the red button, as identified in Figure 7:

6.3.5.3. **Power Up System.** Reconnect the electrical supply removed in step 6.3.2.2 and then switch on the control panel as described in step 6.3.2.1.

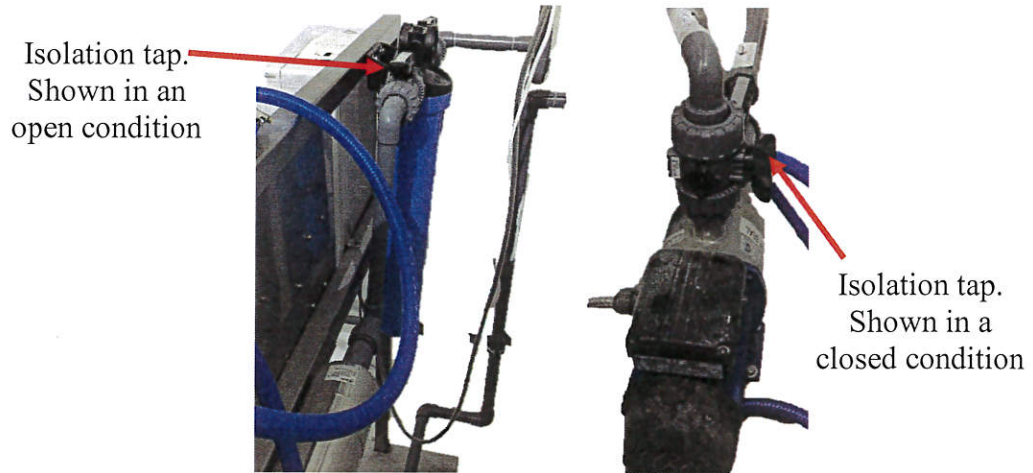
Figure 9: Location of the isolation taps.

6.3.2.3. **Isolate the Water.** Isolate the water supply from both sides of the UV Lamp, using the isolation taps shown in Figure 9:

6.3.5.1. **Reinstate the Water.** Open the water isolation taps as identified in Figure 9:

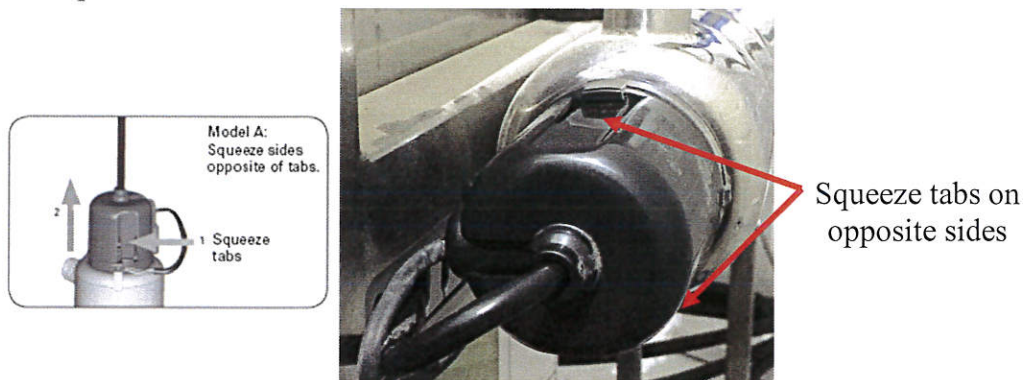
Figure 10: Remove the safety cap.

6.3.2.5. **Remove Safety Cap.** Squeeze both tabs on opposite sides of the safety cap then pull it away from the UV Filter to remove.

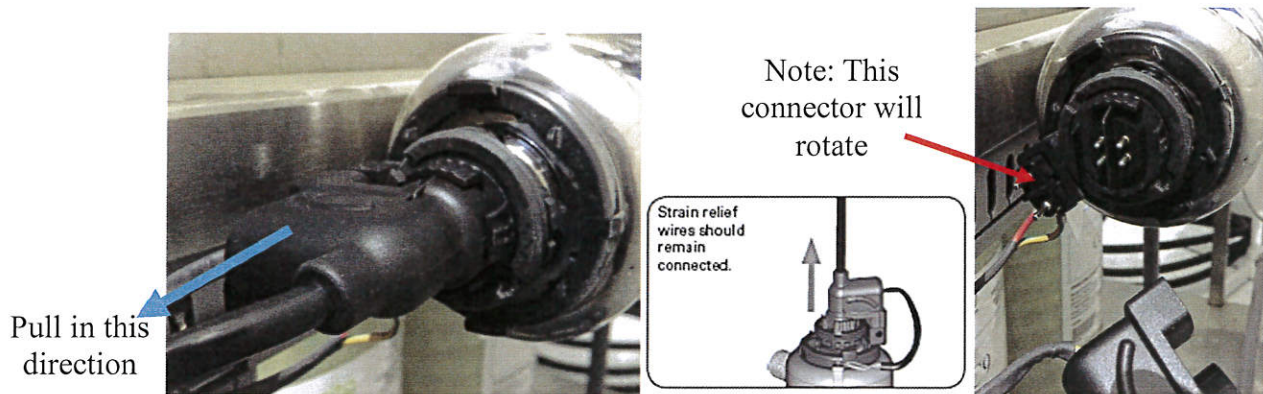
Figure 11: Remove the electrical connections.

- 6.3.2.6. **Remove Electrical Connector.** Remove the electrical connector by pulling the top cap, ensuring that the strain relief wires remain connected.

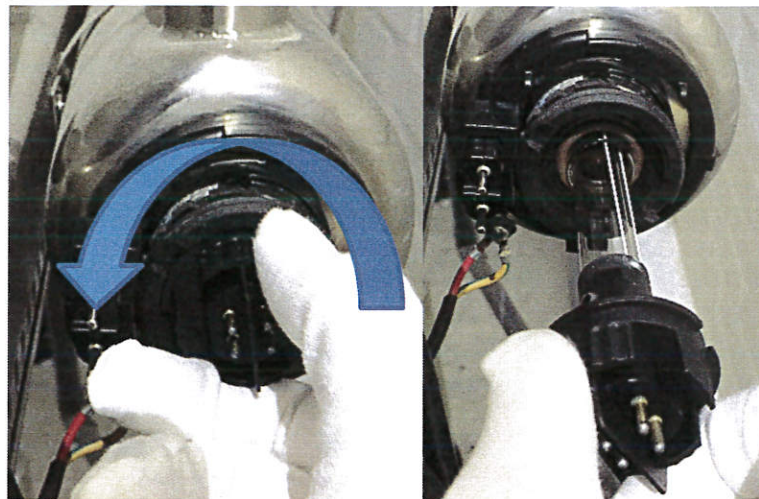
Figure 12: Remove the Lamp/ Sleeve Assembly.

- 6.3.2.7. **Remove the UV Bulb.** Twist the UV Bulb anti-clockwise and withdraw it from the filter housing.

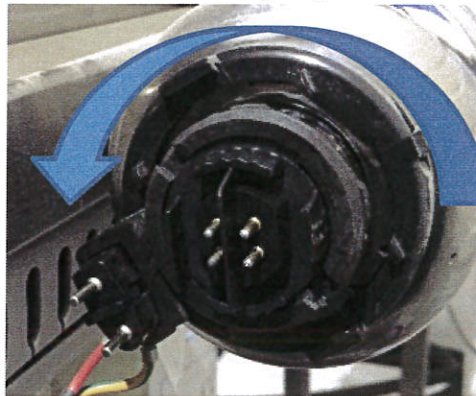
Figure 13: Removal of Sleeve, Note: The sleeve can be removed with or without the UV Bulb in place.

6.3.3.3. **Remove the Sleeve Assembly.** Twist the sleeve bolt anti-clockwise and withdraw it from the filter housing.

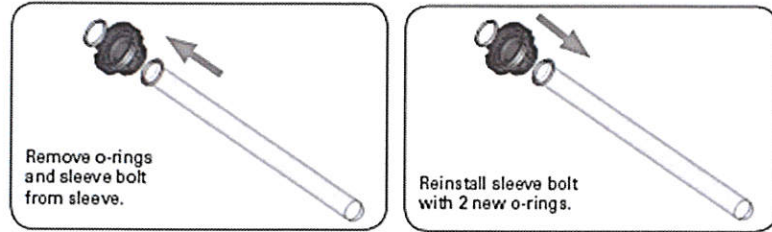
Figure 14: Replace the O-Rings.

6.3.4.2. **Replace the O-Rings from the Sleeve.** Remove Sleeve bolt from the sleeve and replace the two O-Rings included with the new sleeve.

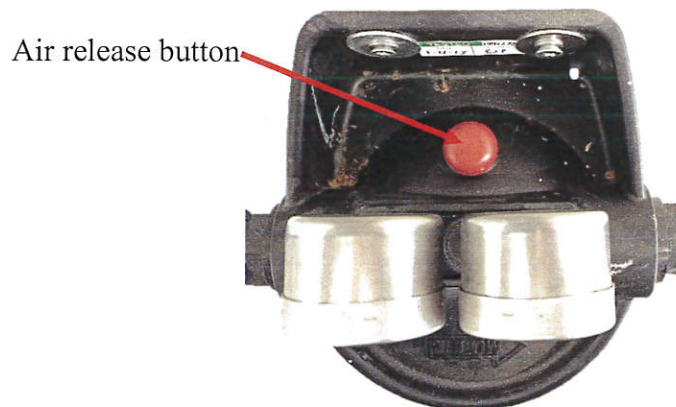
Figure 15: Bleed any trapped air.

6.3.5.2. **Bleed Air From System.** Bleed any trapped air from the system by pressing the Air release button identified in Figure 15:

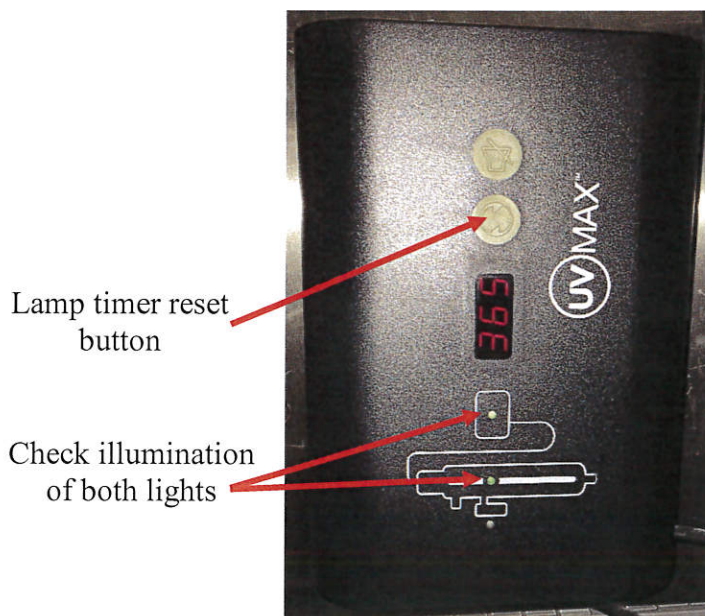
- 6.3.5.4. **Reset the UV Lamp Life Counter, if New Bulb was Fitted.** If a new bulb was fitted in step 6.3.2.8 the bulb life counter will require resetting. Press and hold the Lamp Timer Rest button for five seconds, after the reset the display will read 365, as shown in Figure 16:
- 6.3.5.5. **Record Activity.** Record on Clean Room - Activity Log (Document Number AEU00496).
